## DDI IMAGERY ANALYSIS STAFF

NAME Chu Le Hwy. Bridge SE No. 1 over Song Tien <input type="text"/> Bridge No. 28 on NE 48-7	COUNTRY North Vietnam	COORDINATES 18 10N - 105 43E WF761102	25X1
MAP JOG (A) 1501 NE 48-7		BRIEF NO: PIB 75500 February 1967	25X1

25X1	NAME	Ban Houei Cui Hwy. Bridge	COUNTRY	North Vietnam	COORDINATES	19 19N - 104 20E VG298357
		over stream [redacted] Bridge No. 7 on NE 48-2				
25X1					BRIEF NO:	
	MAP				JOG (A) 1501 NE 48-2	
LOCATION:						1 nm NW of Ban Houei Cui on Route 7.

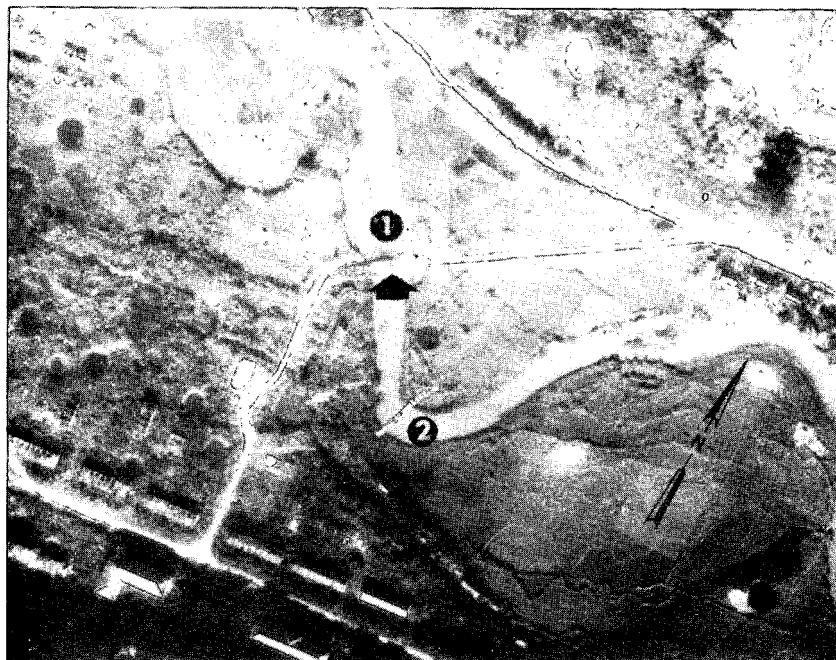
By-Pass No. 1 - constructed 60' x 10' (approx.) ford; probable rock/gravel base; immediately N of main bridge; serviceable.  
By-Pass No. 2 - multi-span [REDACTED] (approx.) wood deck-type bridge; 200' S of main bridge; deteriorated and unserviceable.

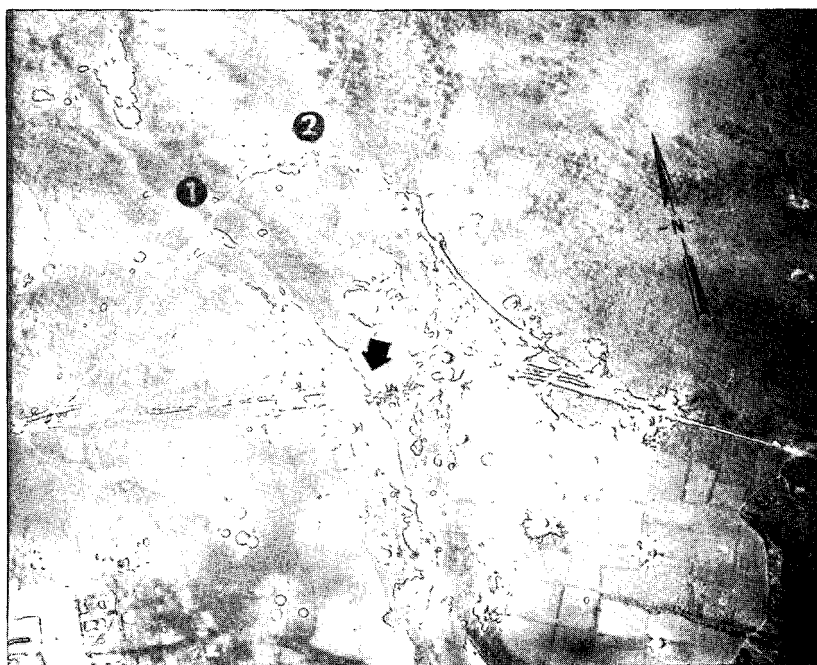
STATUS: Original bridge has been destroyed and is replaced by a 14 span, deck-beam bridge measuring 230' x 5' approx. supported by A-frames and cables. The rail line does not connect with the segment of track over the bridge, suggesting that the bridge is used only to shuttle material over the river.

By-Pass No. 2 - 15 span 225' x 5' (approx.) wood and steel deck-beam bridge supported by A-frames, with spans measuring 15 @ 15' approx.; 1170' NNE of main bridge; serviceable.

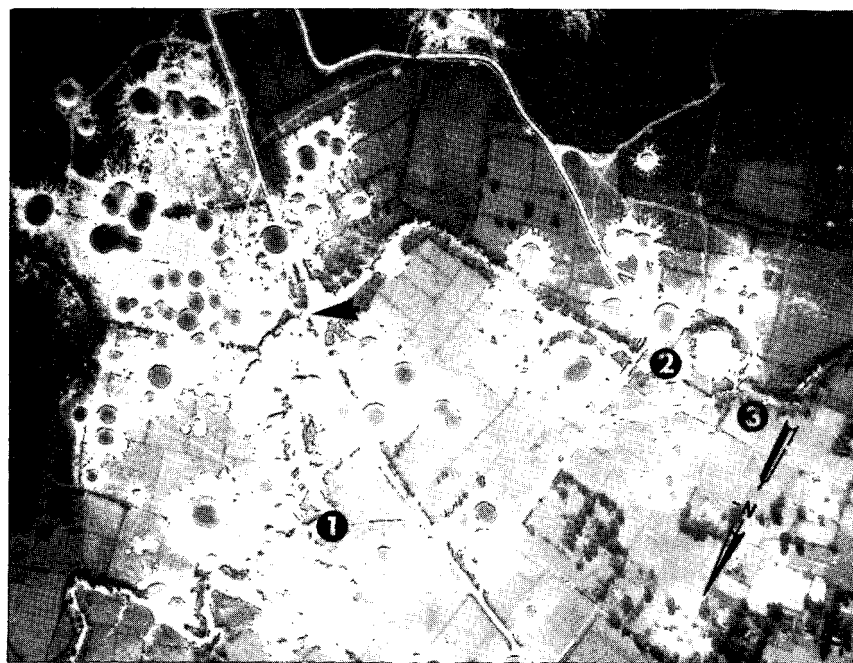
25X1 By-Pass No. 3 - single span  (approx.) wood deck-type bridge;  
1250' WSW of main bridge; serviceable.

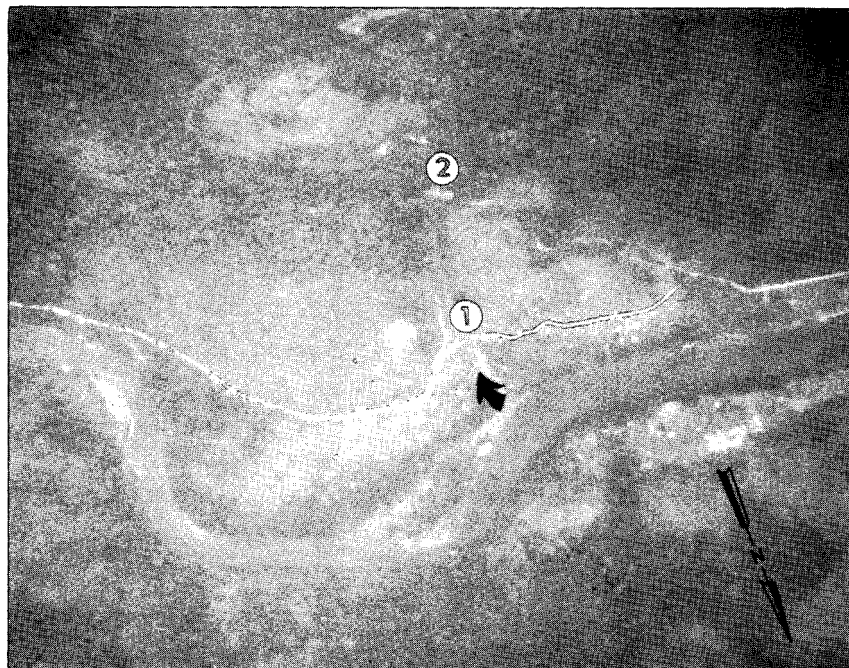
By-Pass No. 1 - [ ] no change [ ]  
 By-Pass No. 2 - single-span [ ] (approx.) probable wood deck-type  
 bridge; 800' S of main bridge; probably serviceable.

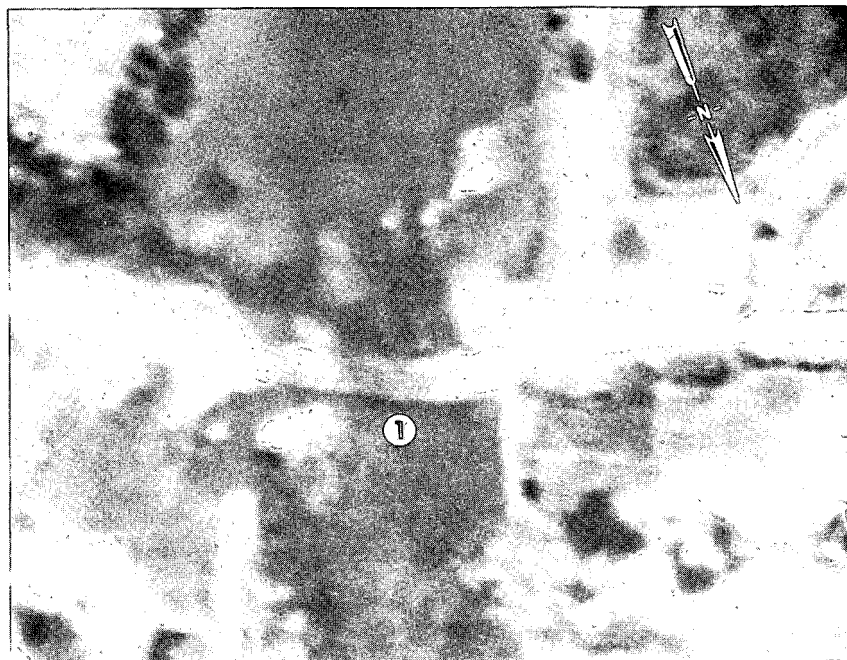
25X1 By-Pass No. 1 - constructed  approx. ford; probable rock/gravel base; alongside main bridge; serviceable.

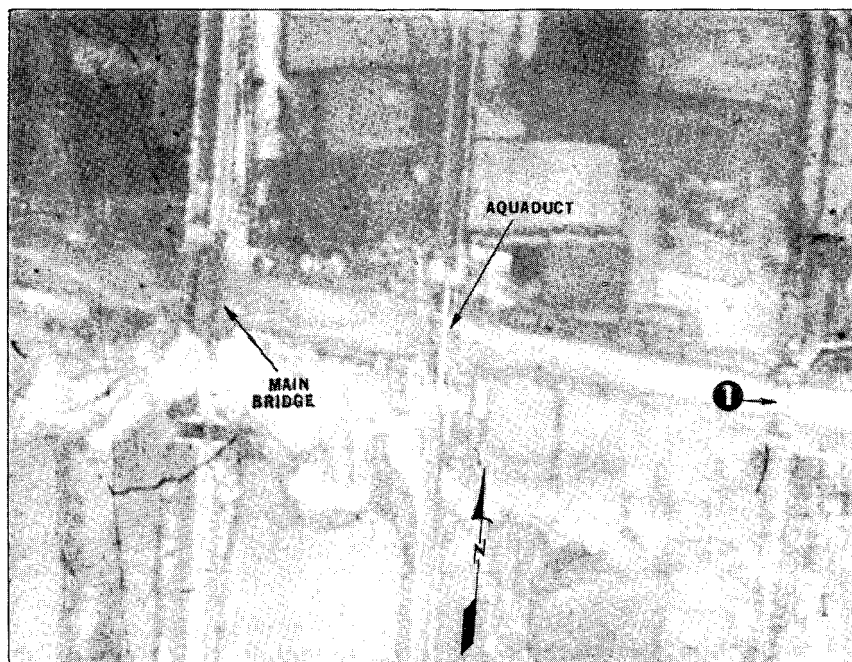
By-Pass No. 1 - single-span (approx.); probable wood deck-beam bridge; 300' E of main bridge; partially dismantled and unserviceable.

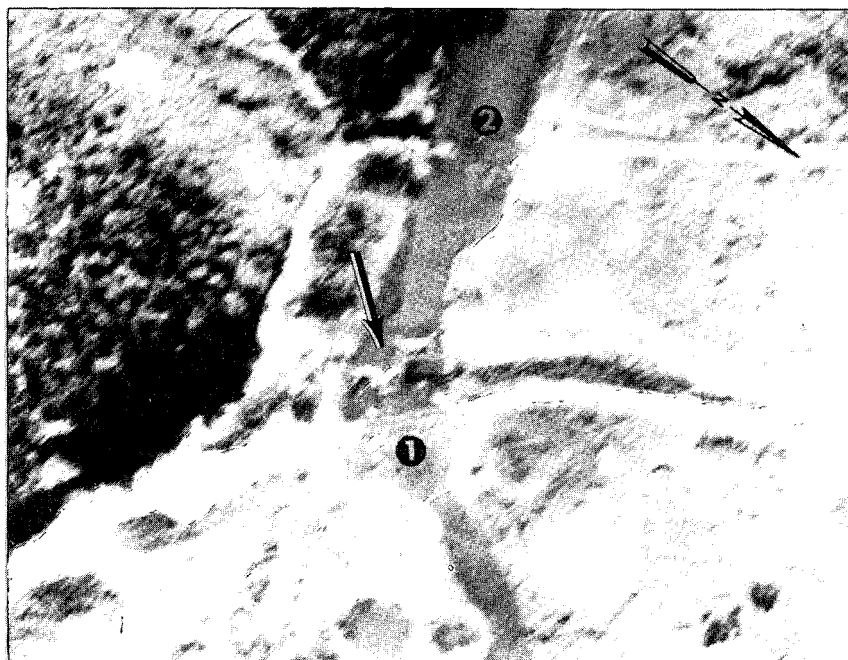
- By-Pass No. 1 - constructed 100' x 15' (approx.) ford; probable rock/gravel base; 45' NE of main bridge; serviceable.
- By-Pass No. 2 - constructed 100' x 15' (approx.) ford; probable rock/gravel base; 200' SW of main bridge; serviceable.

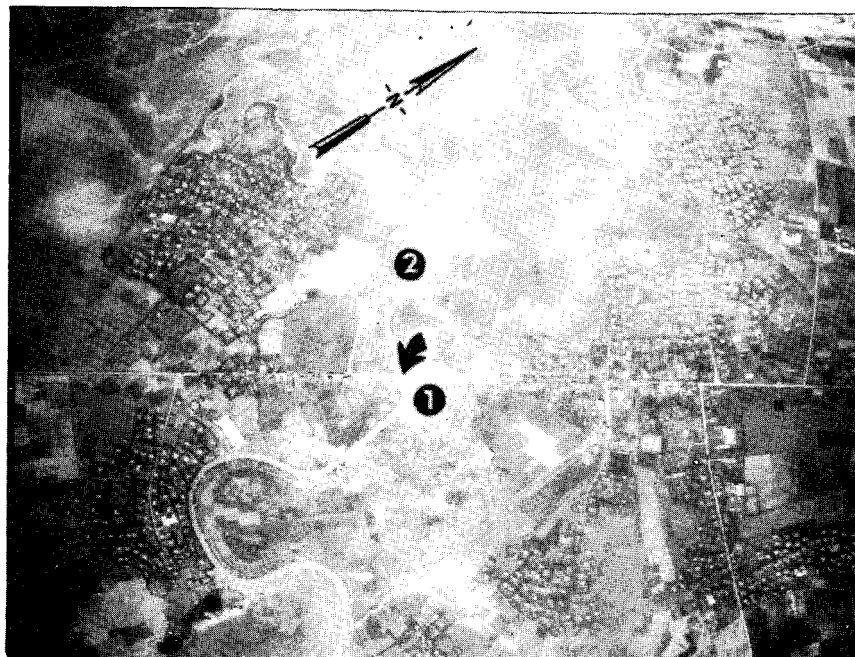
- By-Pass No. 1 - single span [REDACTED] (approx.) timber deck-type bridge with approach causeways on either side; adjacent to SE side of main bridge; serviceable.
- By-Pass No. 2 - possible multi-span 50' x 10' (approx.) timber bridge; length of spans undetermined; approx. 450' NW of main bridge; probably unserviceable.

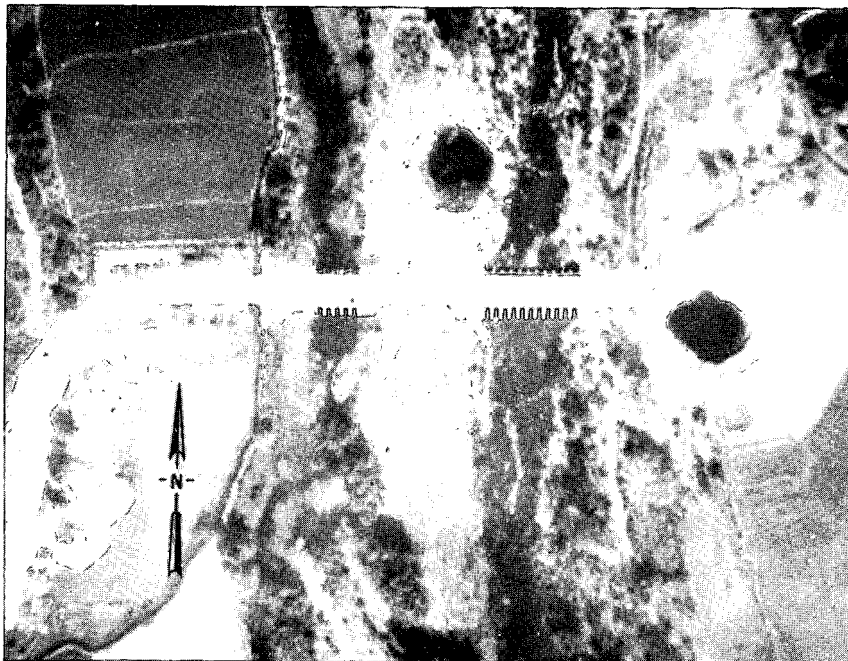
Undamaged; although this bridge/causeway has been constructed to by-pass a ford located 4000' (approx.) to the south, it will now be assessed as the main bridge.

By-Pass No. 1 - natural 120' (approx.) ford; original river crossing of Route 13A; ford appears to be in disuse, however probably is serviceable.

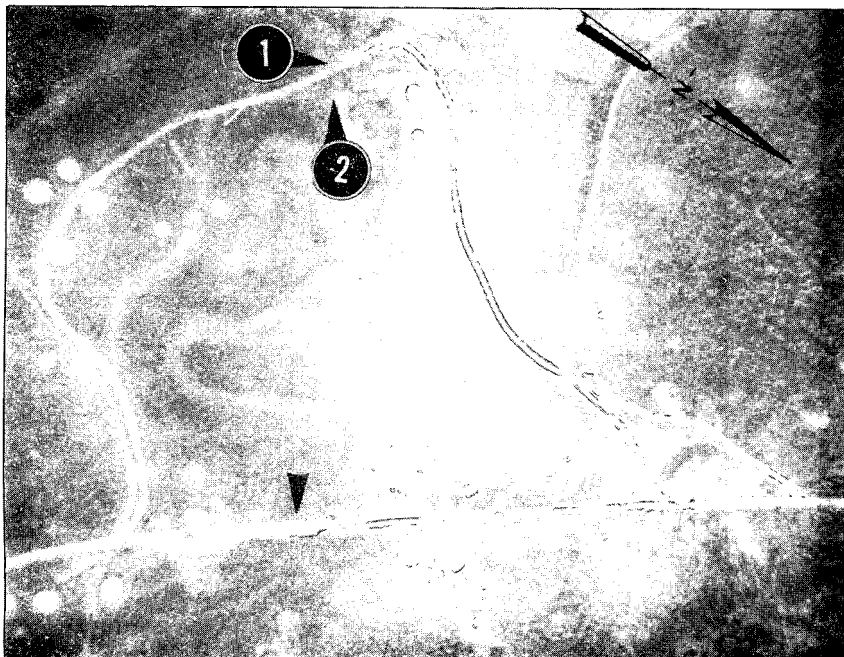
By-Pass No. 1 - single-span  (approx.) probable wood and steel deck type bridge; 2500' (approx.) SW of main bridge; serviceable.  
By-Pass No. 2 - constructed 15' x 10' (approx.) ford; probable rock/gravel base; 2475' (approx.) SW of main bridge; serviceable but inactive.

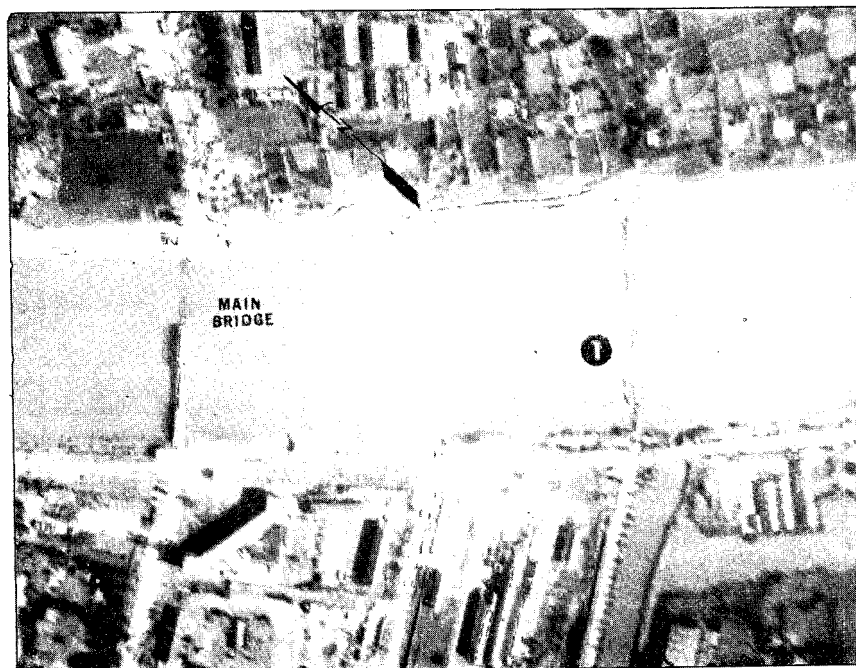
By-Pass No. 1 - 530' x 10' (approx.) probable wood pontoon bridge;  
1000' SE of main bridge; serviceable.

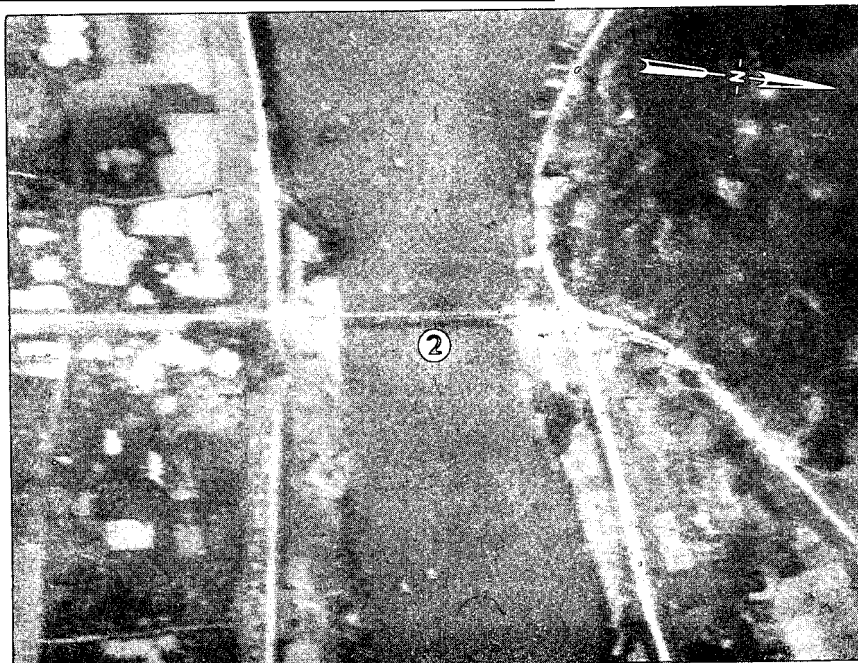
STATUS:  
3 spans dropped; 2 spans slightly damaged.

25X1 By-Pass No. 2 - [REDACTED] (rail only); 6-span [REDACTED] (approx.) steel and timber deck beam bridge with spans measuring 45' approx.; approx. 9000' SW of main bridge; repaired and serviceable.

25X1 By-Pass No. 4 - [REDACTED] (rail only); multi-span [REDACTED] (approx.) probable wood deck beam bridge with spans of unknown dimensions; approx. 850' W of main bridge; abandoned construction.

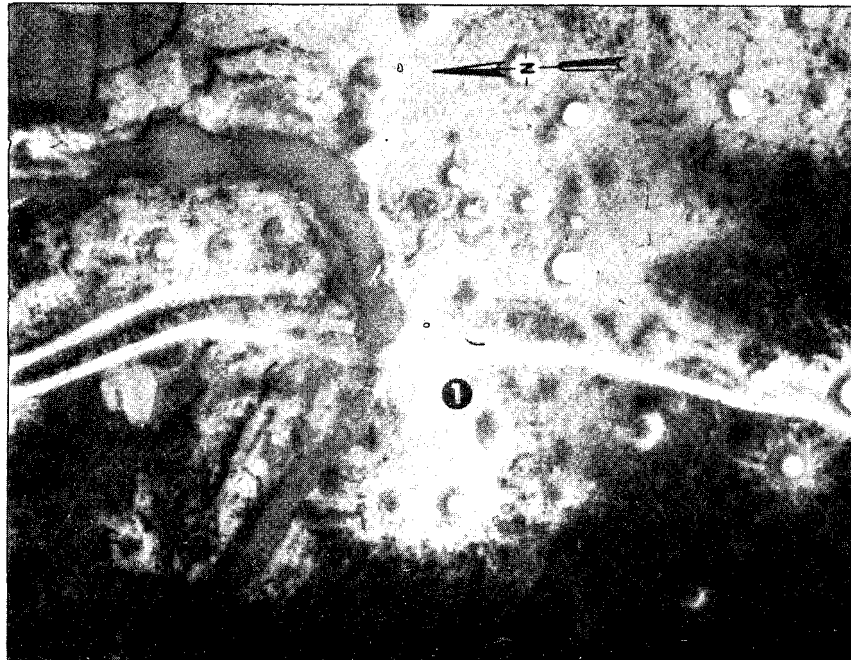
By-Pass No. 1 - constructed 30' x 10' (approx.) ford; probable rock/gravel base; 25' S of main bridge; serviceable.

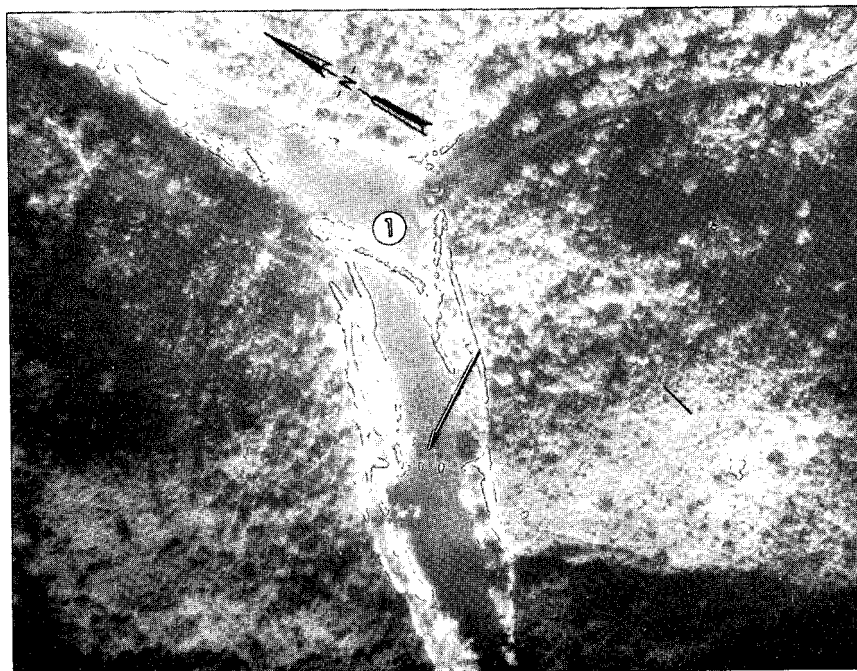
By-Pass No. 1 - constructed 120' x 15' (approx.) ford; probable rock/gravel base; 250' NE of main bridge; serviceable.

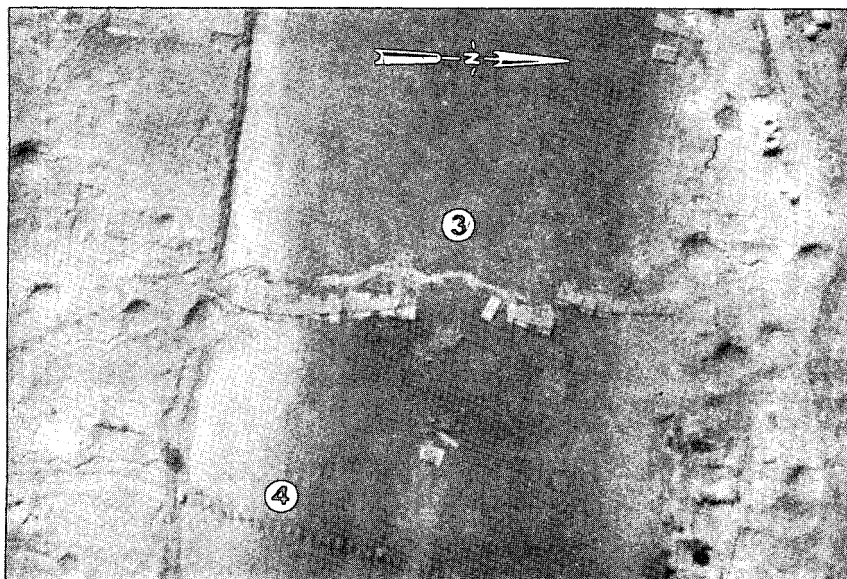
By-Pass No. 3 -	500' pontoon highway bridge; 850' W of main bridge; pontoon				
		sections heavily damaged; bridge unserviceable.				
	By-Pass No. 4 -	No change	[REDACTED]			25X1
25X1	[REDACTED]

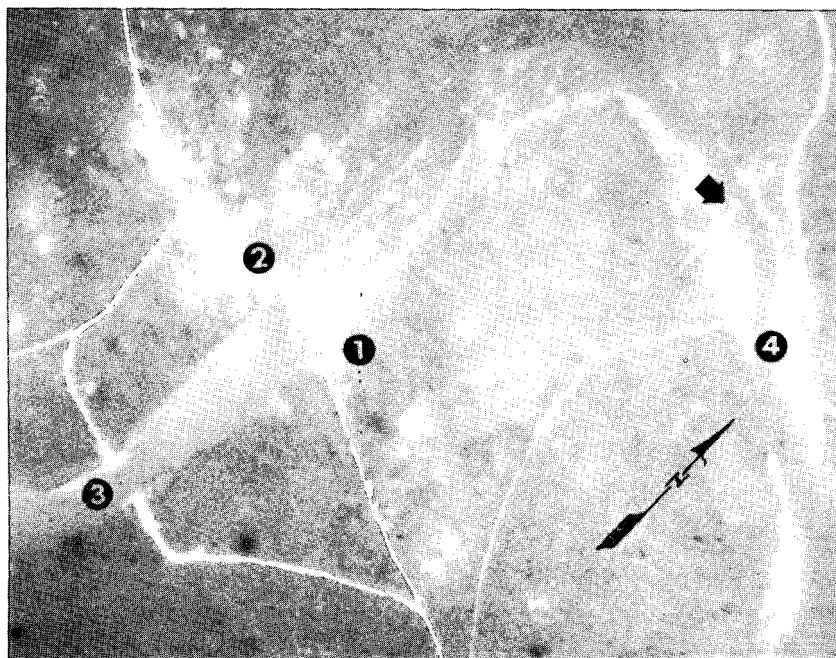
- 25X1 By-Pass No. 1 - single span [REDACTED] probable wood deck-type bridge; 735' SW of main bridge; serviceable.
- 25X1 By-Pass No. 2 - single span [REDACTED] probable wood deck-type bridge; 740' SW of main bridge; serviceable.
- By-Pass No. 3 - ferry landings located 1075' S of main bridge; serviceable; 1 ferryboat noted.
- By-Pass No. 4 - probable natural 100' ford; 300' E of main bridge; probably serviceable.

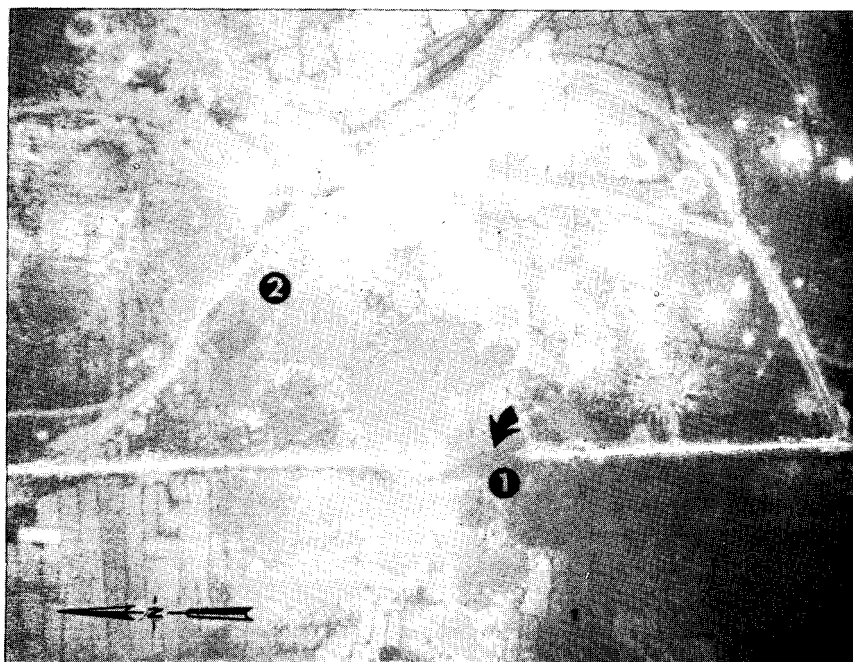
- 25X1 By-Pass No. 1 - constructed  ford; probable rock/gravel base; adjacent to W side of main bridge site; unserviceable.
- 25X1 By-Pass No. 2 - combination multi-span  timber deck-type bridge/ probable rock-fill causeway; 250' NE of main bridge; serviceable.

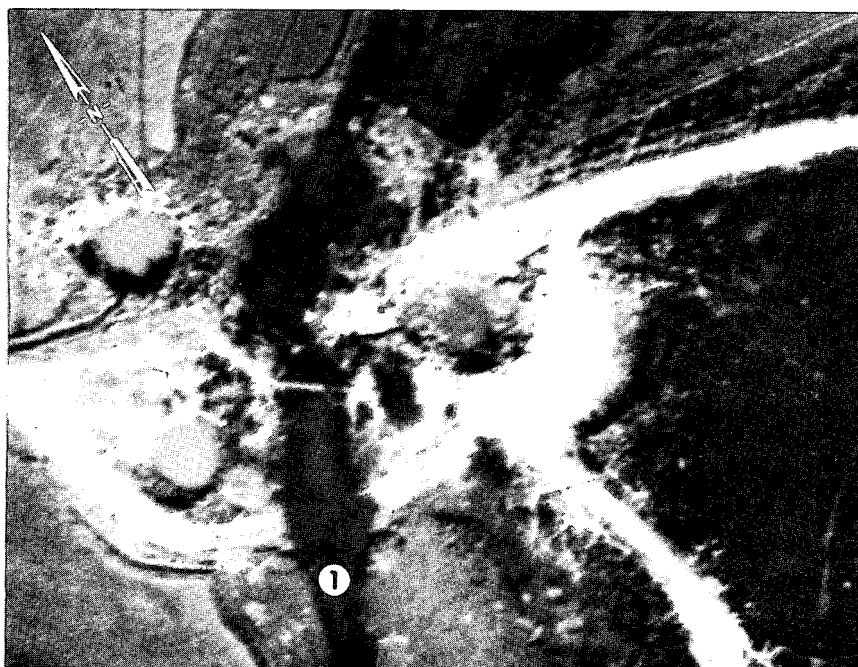
By-Pass No. 1 - natural 35' ford; 100' SW of main bridge; serviceable.

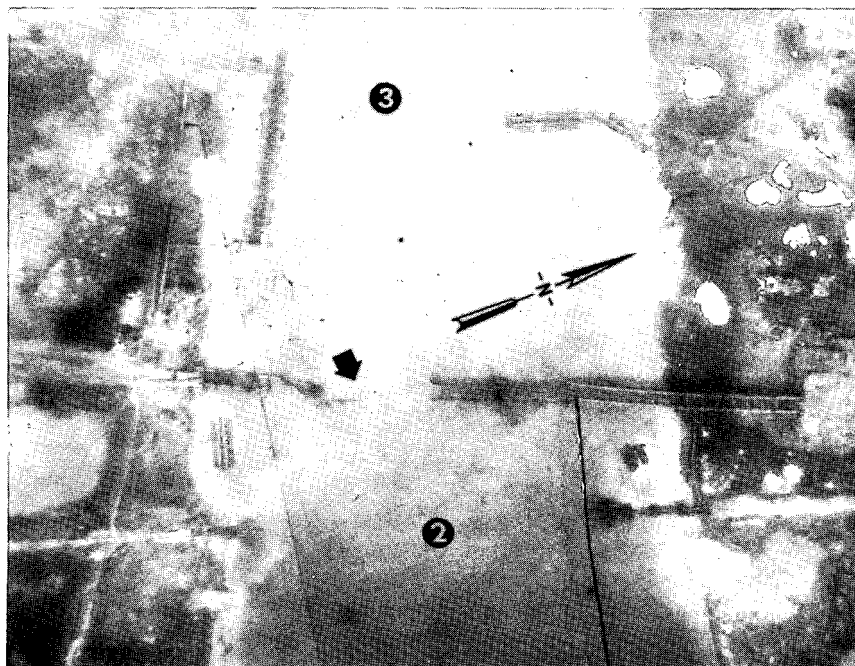
By-Pass No. 2 - Rail ferry landings located 140' E of main bridge; probably serviceable; no ferry boats noted.

25X1 By-Pass No. 3 - [REDACTED] 425' wood and steel rail pontoon bridge; 270' W of main bridge; both approaches cratered, 1 pontoon section destroyed, 1 damaged; unserviceable.

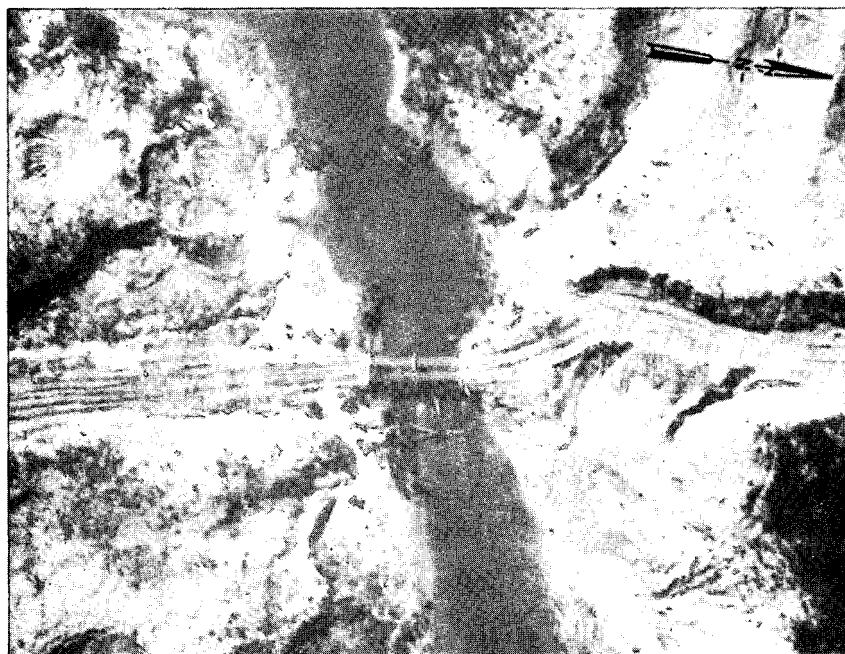
1 abutment damaged; 1 abutment possibly damaged; 1 pier damaged; 2 spans severely damaged; 1 span moderately damaged.

Bridge repaired and serviceable.

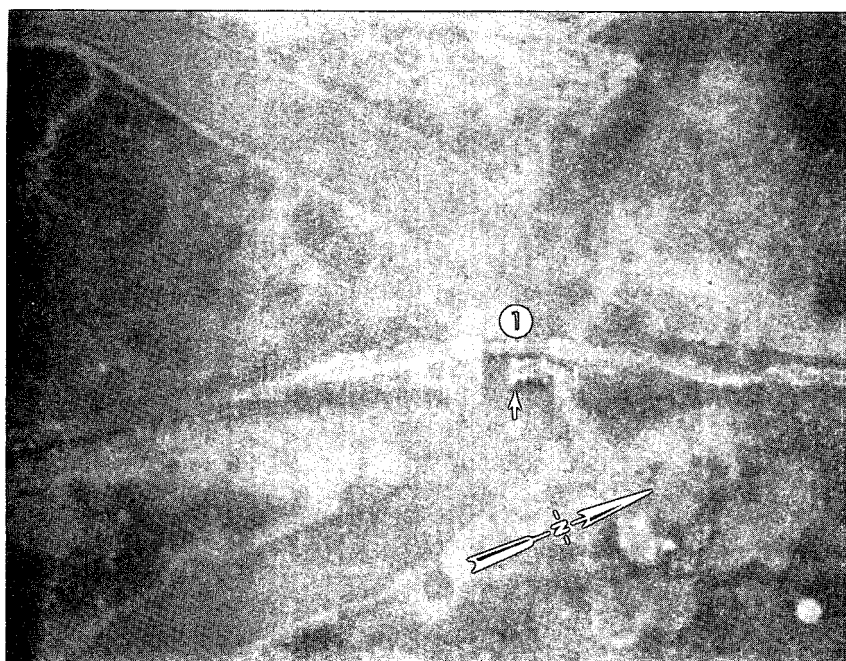
3 spans destroyed; 1 span partially damaged.

By-Pass No. 1 - 4 span   timber deck-type bridge with spans measuring 20'; immediately W of main bridge; serviceable.

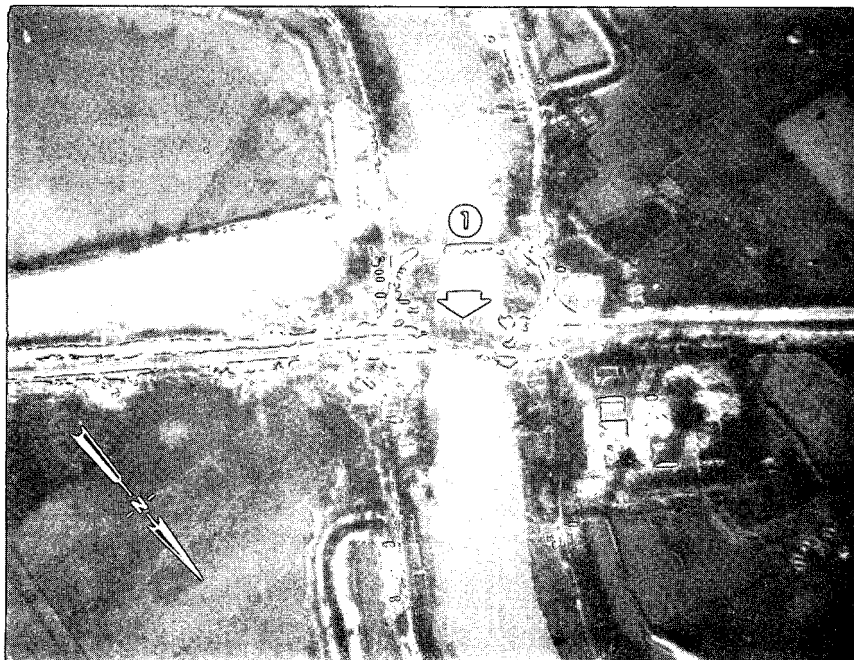
NOTE: Status of adjacent railroad bridge is described in PIB 75570.  
 All measurements are approximate.

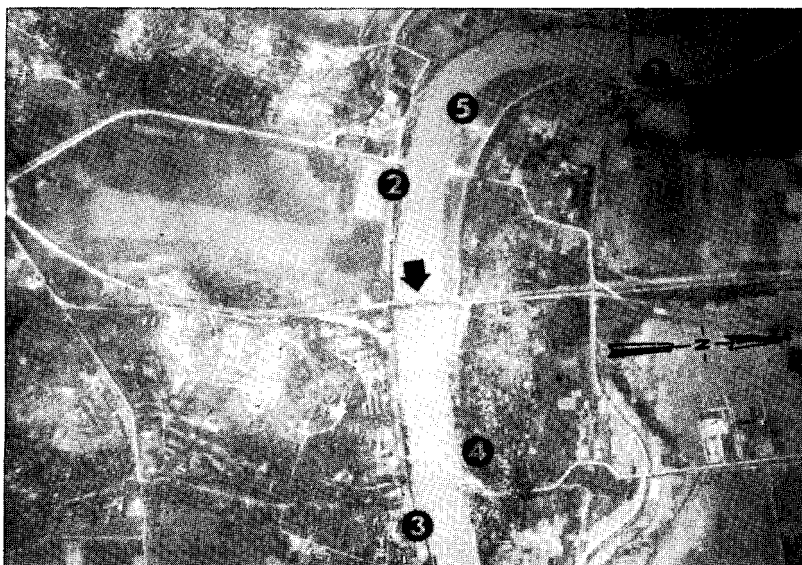
STATUS: The 150' deck span has been repaired; two 40' spans remain damaged.

By-Pass No. 4 - vehicle ferry landings located 1600' E of main bridge;  
serviceable; 2 ferry boats noted.

By-Pass No. 5 - vehicle ferry landings located 1400' W of main bridge;  
serviceable; 1 ferry boat noted.

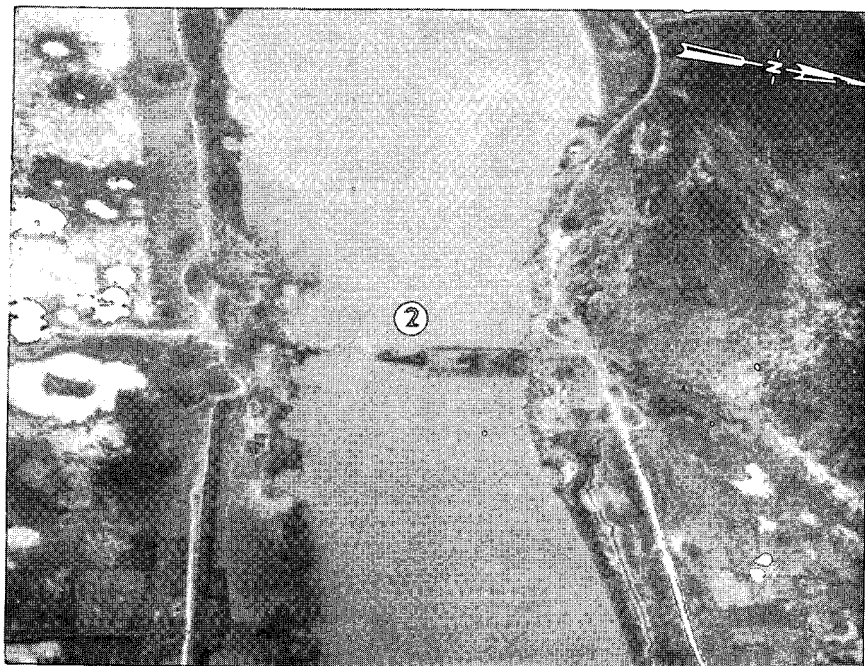
By-Pass No. 1 - no change [REDACTED] (not illustrated). 25X1  
 By-Pass No. 2 - [REDACTED] 6-span [REDACTED] steel and timber deck 25X1  
 beam bridge with 45' spans; 9000' SW of main bridge; 4 spans  
 dropped, 1 span severely damaged, 1 pier destroyed, 2 piers  
 severely damaged; unserviceable.  
 By-Pass No. 3 - no change [REDACTED] (not illustrated). 25X1

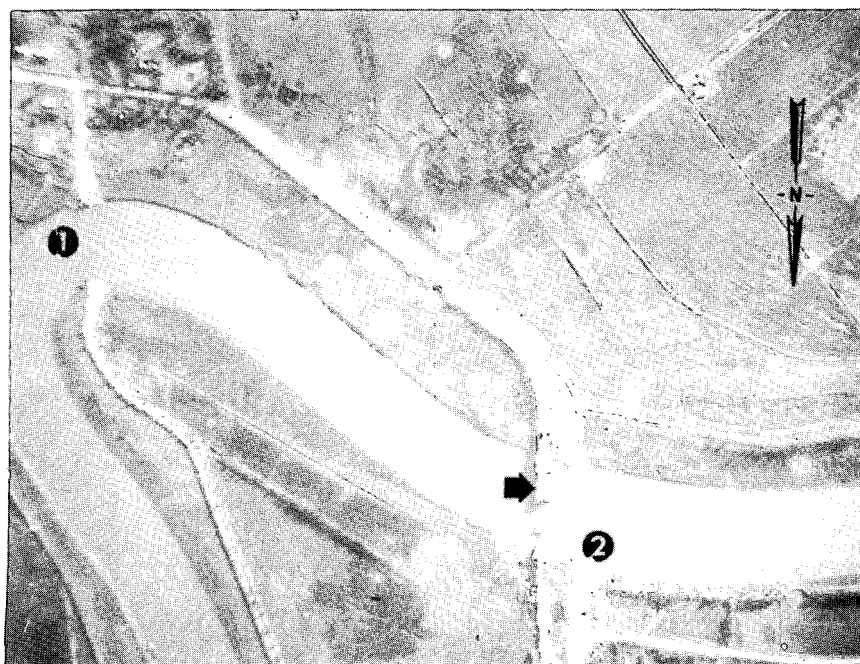
By-Pass No. 1 - a 300' pontoon bridge crossing site; 650' E of main bridge; approaches serviceable; pontoon sections noted W of main bridge.

By-Pass No. 2 - a 350' pontoon bridge crossing site; 40' W of main bridge; approaches serviceable; pontoon sections noted W of main bridge.

NOTE: All measurements are approximate.  
Pontoon sections for By-Pass Nos. 1 and 2 are not illustrated.

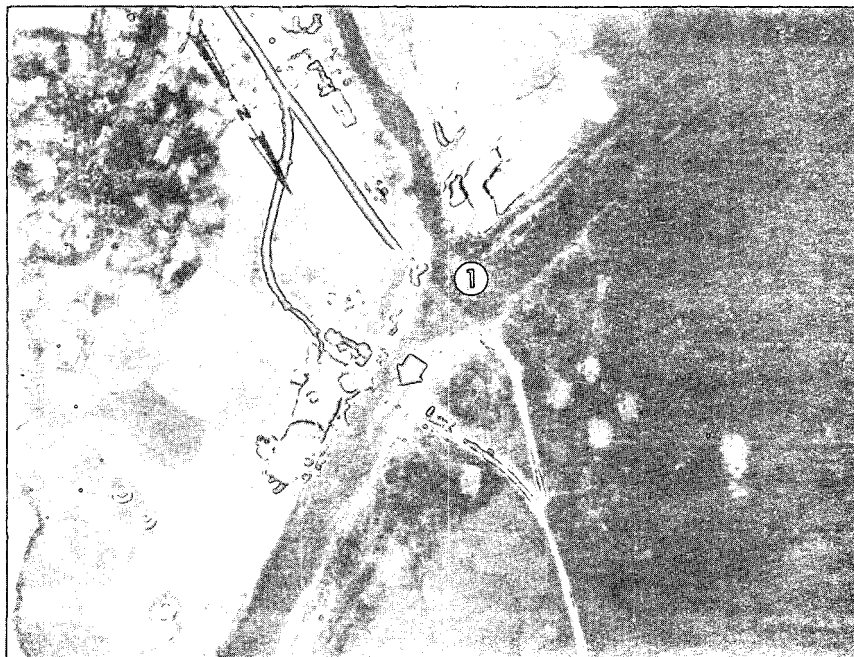
By-Pass No. 1 - constructed 230' x 20' ford; probable rock/gravel base;  
240' W of main bridge; serviceable.

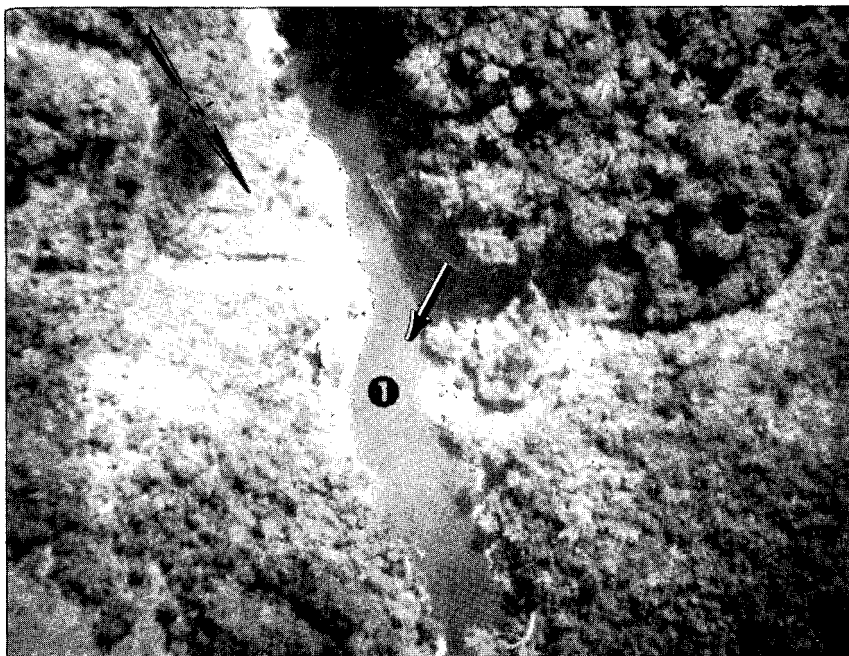
25X1 By-Pass No. 1 - [ ] natural 55' ford adjacent to bridge;  
unused but possibly serviceable.

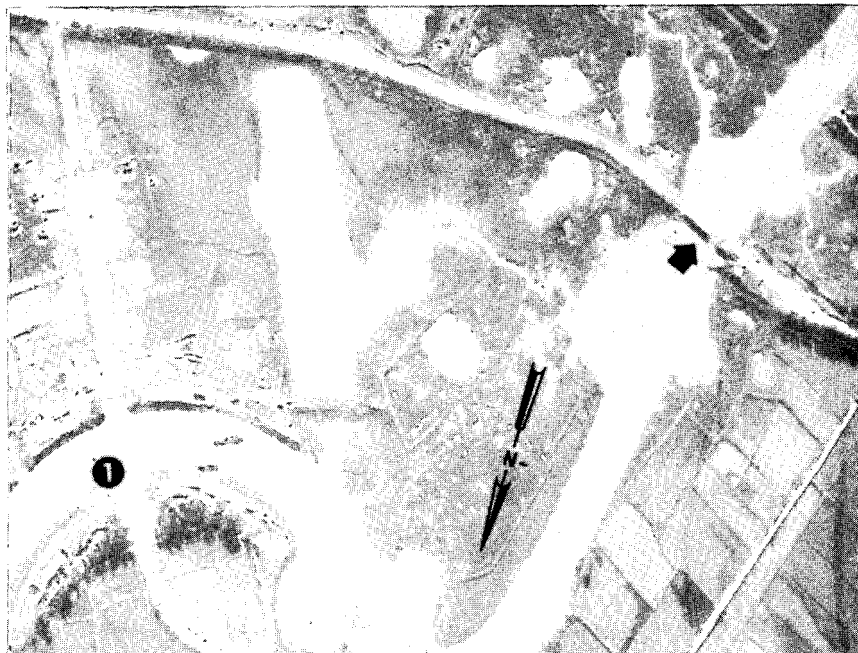
By-Pass No. 1 - ferry landings 350' E of main bridge; serviceable; no  
ferryboats noted.

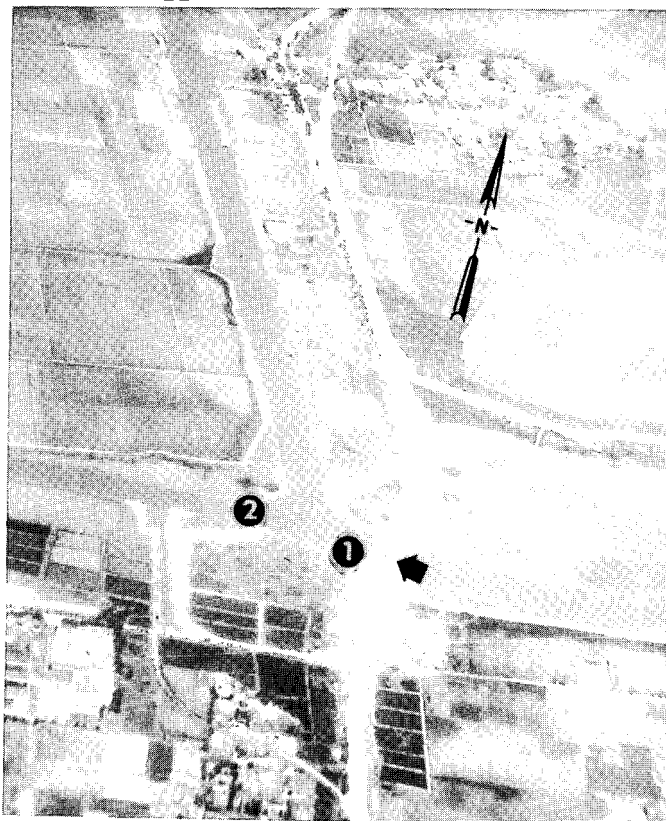
By-Pass No. 2 - 300' highway pontoon bridge site; 300' W of main bridge;  
approaches serviceable; pontoon sections moored downstream  
from main bridge.

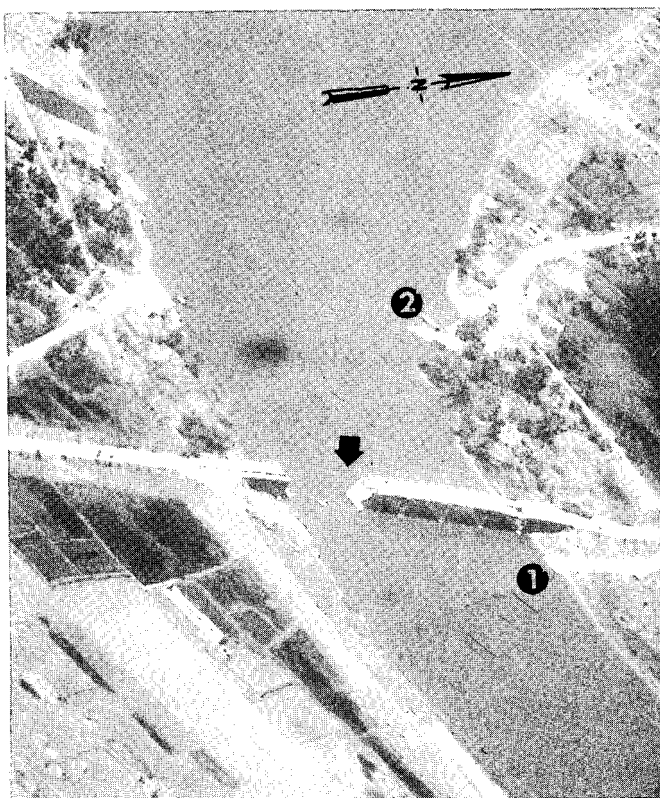
- By-Pass No. 1 - ferry landings located 50' E of main bridge; serviceable; no ferryboats noted.
- By-Pass No. 2 - ferry landings located 300' W of main bridge; serviceable; 1 possible ferryboat noted.

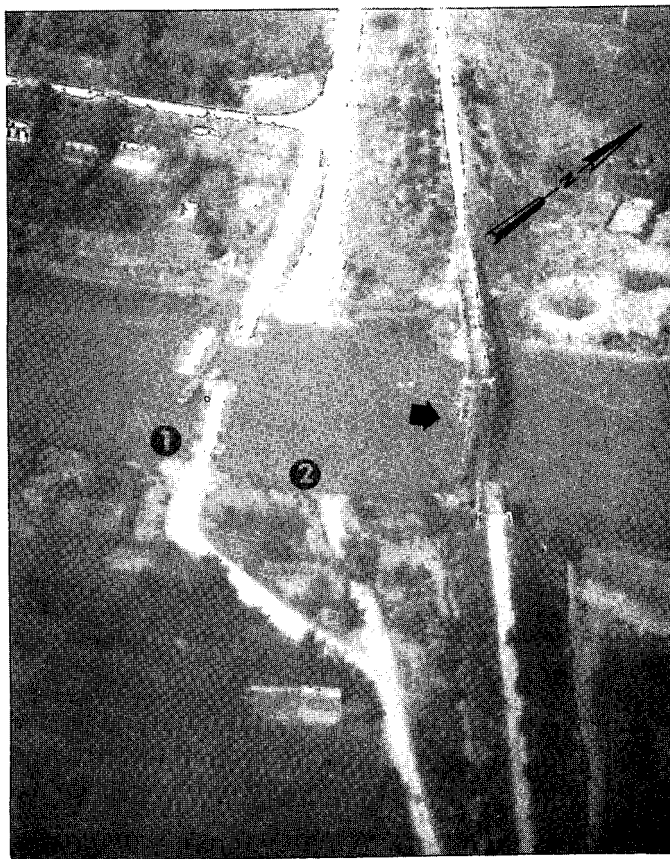
By-Pass No. 2 - 230' pontoon bridge/ferry landings site; 250' SW of main bridge; no ferryboats noted; landings serviceable.

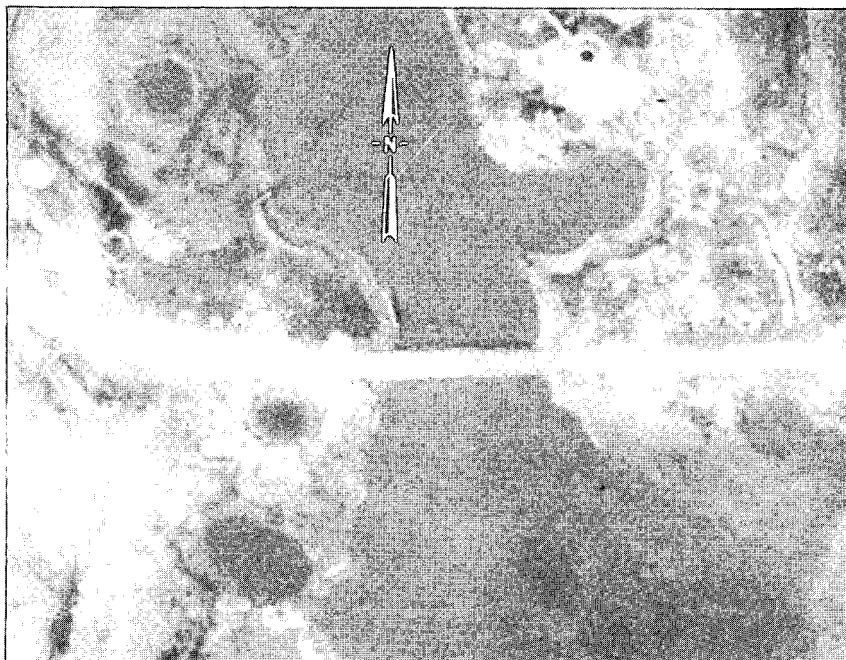
Serviceable replacement bridge.

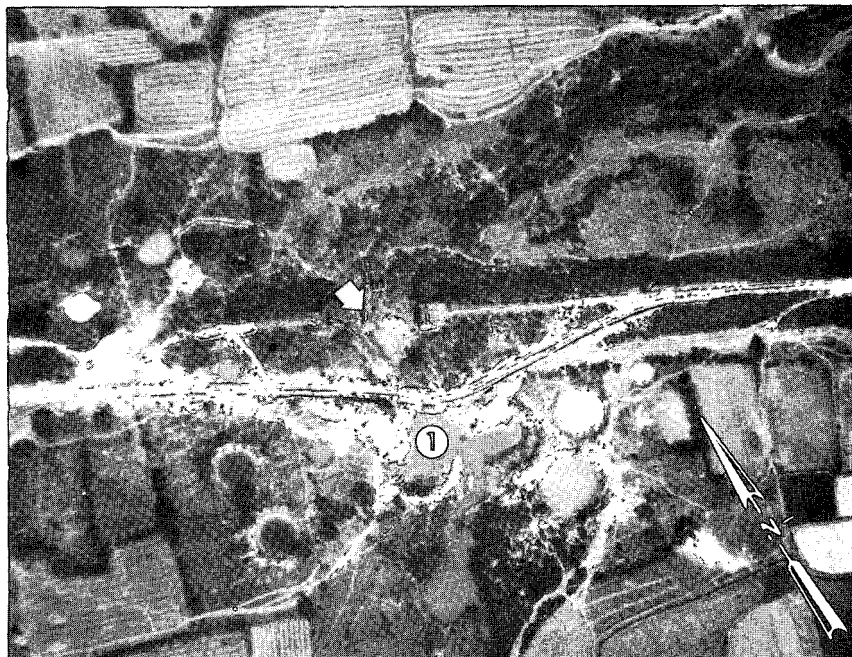
By-Pass No. 1 - bridge replaced by a [REDACTED] gravel/rock causeway; 70' S of main bridge; serviceable. 25X1

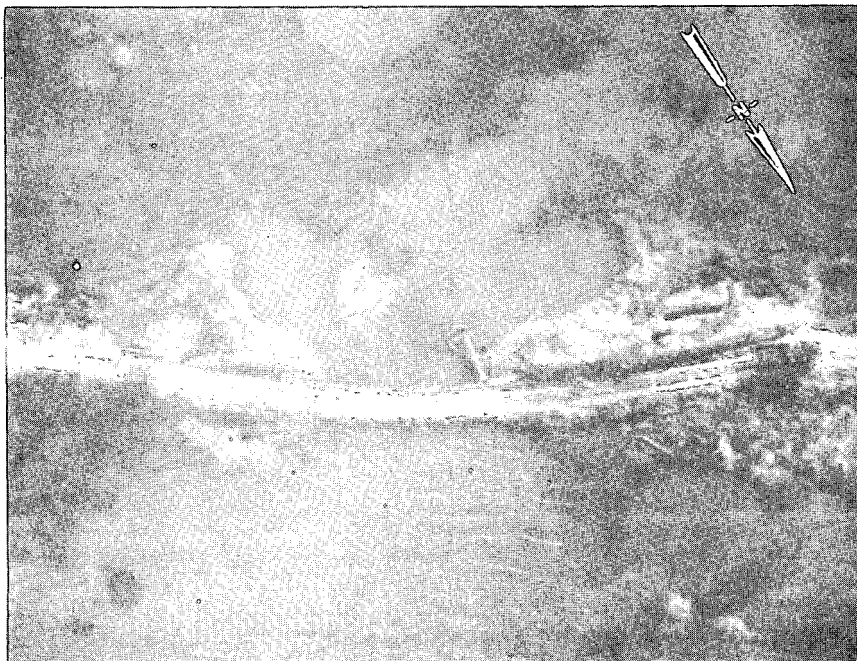
25X1	NAME	Thuy Lien Thuong Hwy. Bridge	COUNTRY		COORDINATES	17 10N - 106 54E
		No. 1 over stream <input type="text"/>		North Vietnam		YD034992
25X1		Bridge No. 10 on NE 48-12			BRIEF NO:	
		<input type="text"/>			PIB 75587	April 1967
	MAP	JOG (A) 1501 NE 48-12				
	LOCATION:	0.8 nm W of Tram Trung on Route 1A.				
	DESCRIPTION:					
	LENGTH	65'	MATERIAL	Concrete		
	WIDTH	15'	NO. OF SPANS	1		
	TYPE	Deck	LENGTH OF EACH SPAN	65'		
25X1	STATUS:	Original bridge destroyed; replaced by a <input type="text"/> timber deck bridge with				
25X1		6 probable <input type="text"/> spans; replacement bridge utilizes one abutment of the original bridge.				
	COMPENSATIVE ACTION:	None

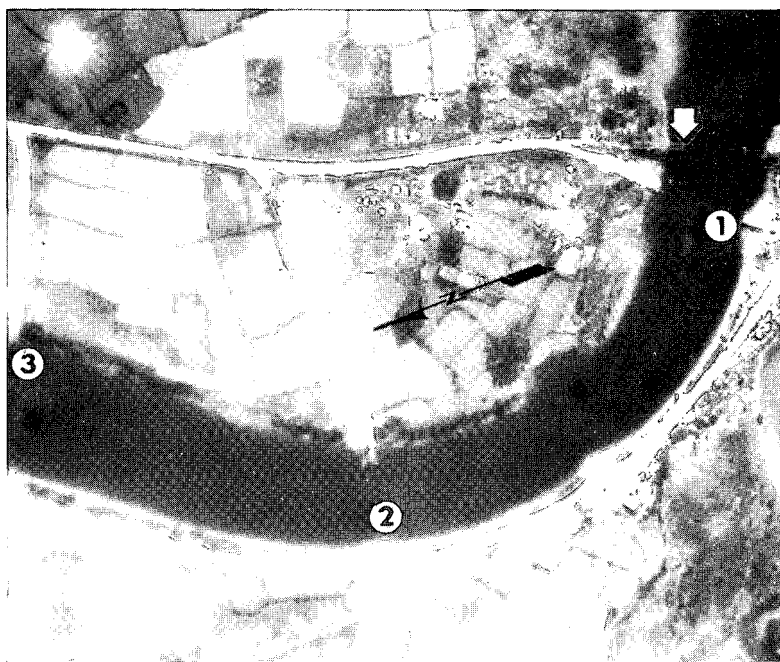
Replacement cable bridge unserviceable; cables have apparently been removed; no new bomb damage observed.

- By-Pass No. 1 - ferry landings 100' W of main bridge; serviceable; no ferryboats noted.
- By-Pass No. 2 - ferry landings 360' NW of main bridge; serviceable; no ferryboats noted.
- By-Pass No. 3 - ferry landings 500' NW of main bridge; serviceable; no ferryboats noted.
